**FINAL**  
**BLACKSTONE RIVER BASIN**  
**WORCESTER, MASSACHUSETTS**

**LEESVILLE POND DAM**  
**MA 00141**

**PHASE I INSPECTION REPORT**  
**NATIONAL DAM INSPECTION PROGRAM**

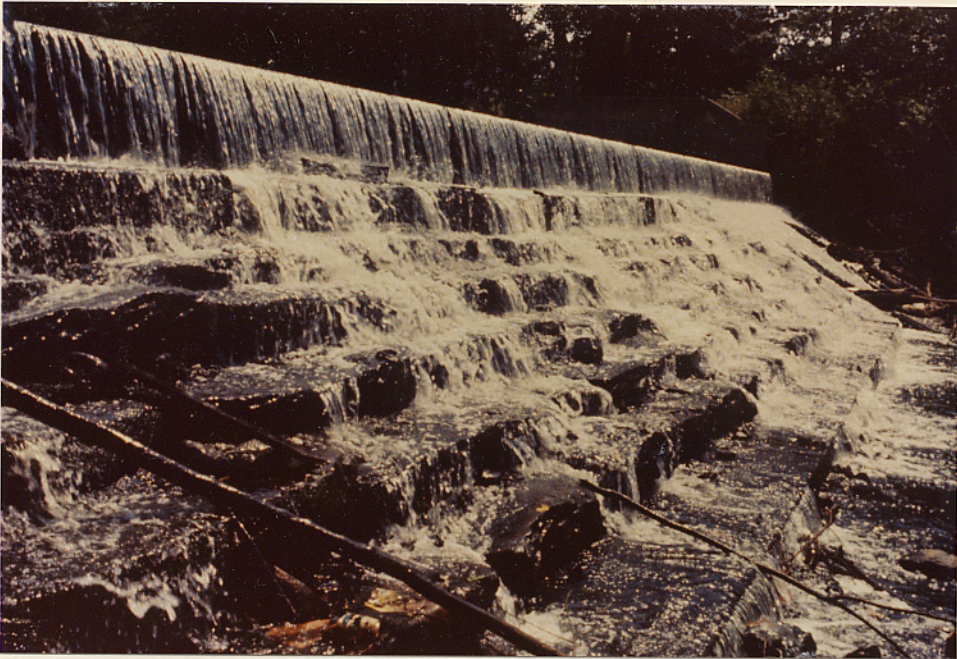
NO. 1 VIEW OF SPILLWAY CASCADE FROM NORTH ABUTMENT

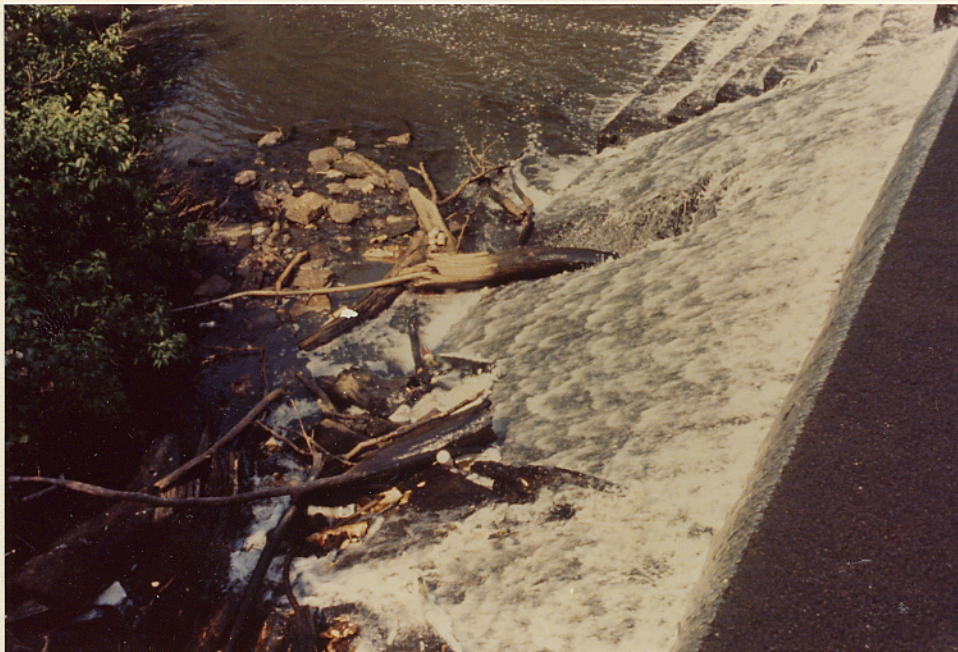
- c. Appurtenant Structures. The concrete and stonework on the spillway are in fair to good condition. Holes for flashboard pins are still visible on the weir and there is minor spalling and erosion on the training walls. The concrete face south of the stepped section is in good condition. Seepage is evident at the toe of the north spillway abutment (see Figure B-1). A tree is growing at that location and the seepage appears to be following the roots.

NO. 2 VIEW OF SPILLWAY FROM SOUTH ABUTMENT

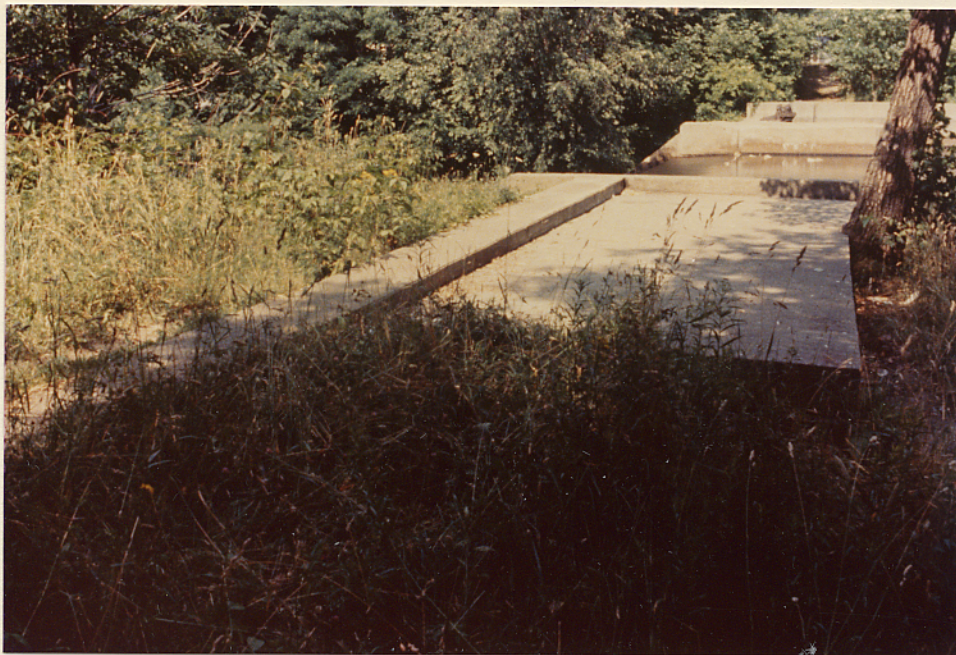
- b. Dam. Leesville Pond Dam is an earthfill dam with a wood plank core wall and a reinforced concrete capwall and apron. In general, the concrete is in good condition although there is slight spalling of the concrete at the joints in the capwall. The concrete apron and capwall tie into natural ground at the abutments. The abutment area is eroded on both the upstream and downstream slopes. On the upstream slope of the south embankment area, there is some random riprap protecting the face, however, slight slumping of the soil is visible. At the northern upstream face, a few riprap stones are visible. The upstream and downstream slopes of both embankments are overgrown with vegetation, including a number of 12- to 18-inch diameter trees on the upstream face of the south embankment.

**NO. 3 VIEW OF DAM CREST FROM SOUTH ABUTMENT**

- (3) cut down trees and clear brush from both embankments, the sides of the outlet channel, and the toe of the north spillway abutment
- (4) repair eroded areas of the downstream face of the abutments, and replace the rip-rap on the upstream face of the dam

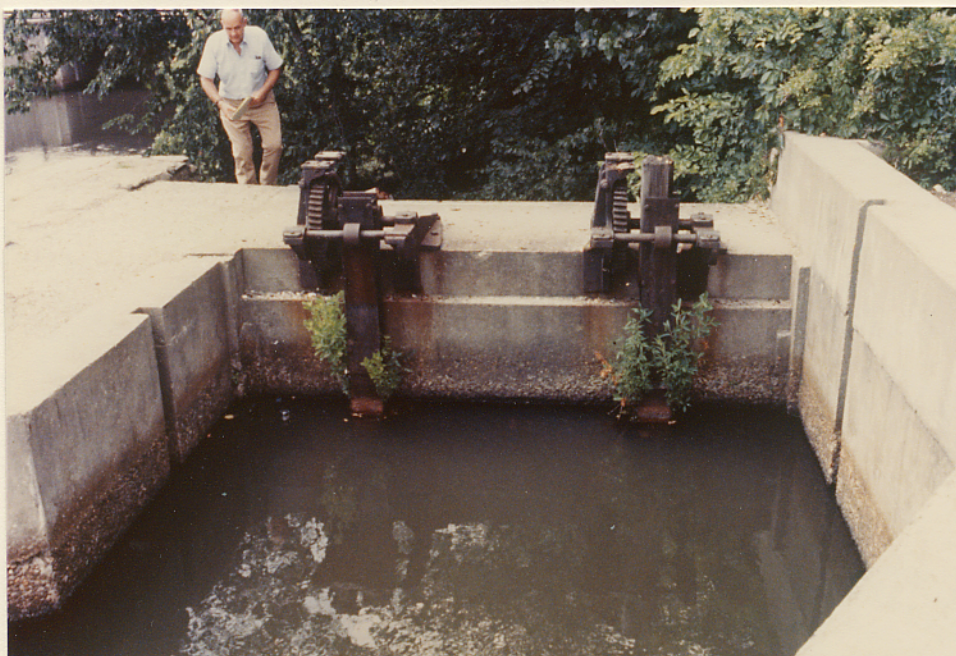
**NO. 4 VIEW OF INTAKE CHANNEL**

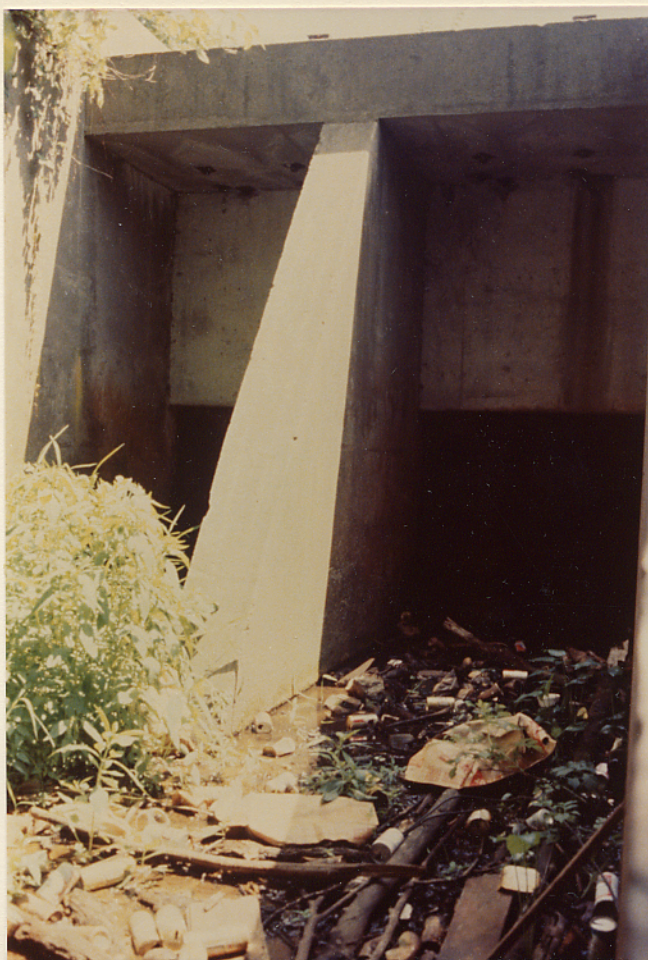
The outlet structure is in poor condition. The intake to the gates is submerged and there is evidence of cracking along the joints on the training walls and erosion along the water line. The slide gates are presently inoperable and it is not known when they were last used. The rack and pinion mechanisms above the gates are rusted, and the wooden parts have rotted away. There is leakage along the top of both wooden gates. In general the concrete outlet channel is in fair condition with only minor spalling, but the floor of the channel is cluttered with wood and trash. One large and several smaller trees and brush have overgrown the outlet channel.

NO. 5 VIEW OF DISCHARGE CHANNEL AND SLIDE GATES

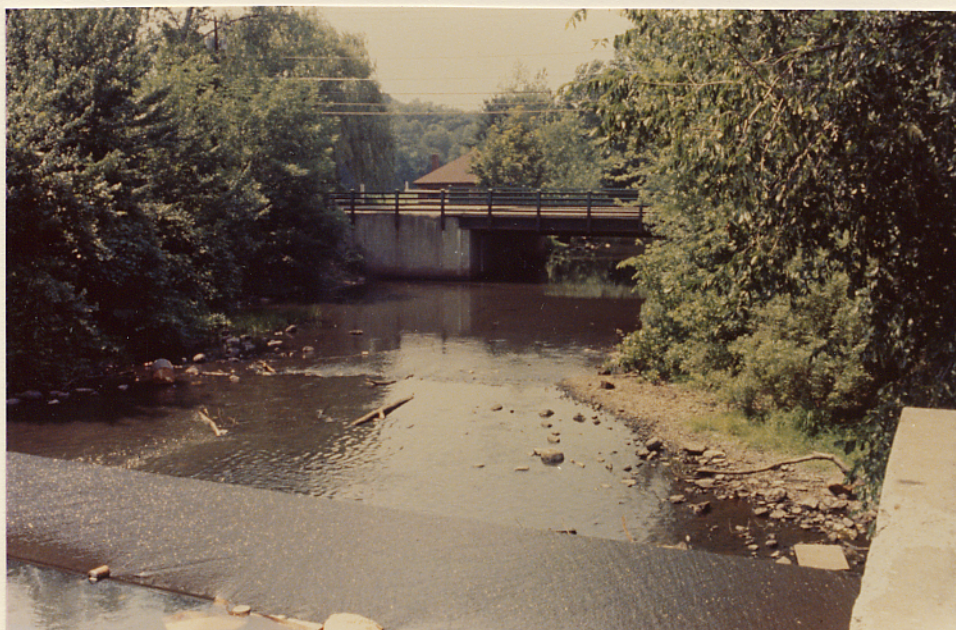
NO. 6 VIEW OF CHANNEL DOWNSTREAM OF DAM
